Notes from Glenmore Woods Landscape Committee Property Walk

April 18, 2009 9:00am

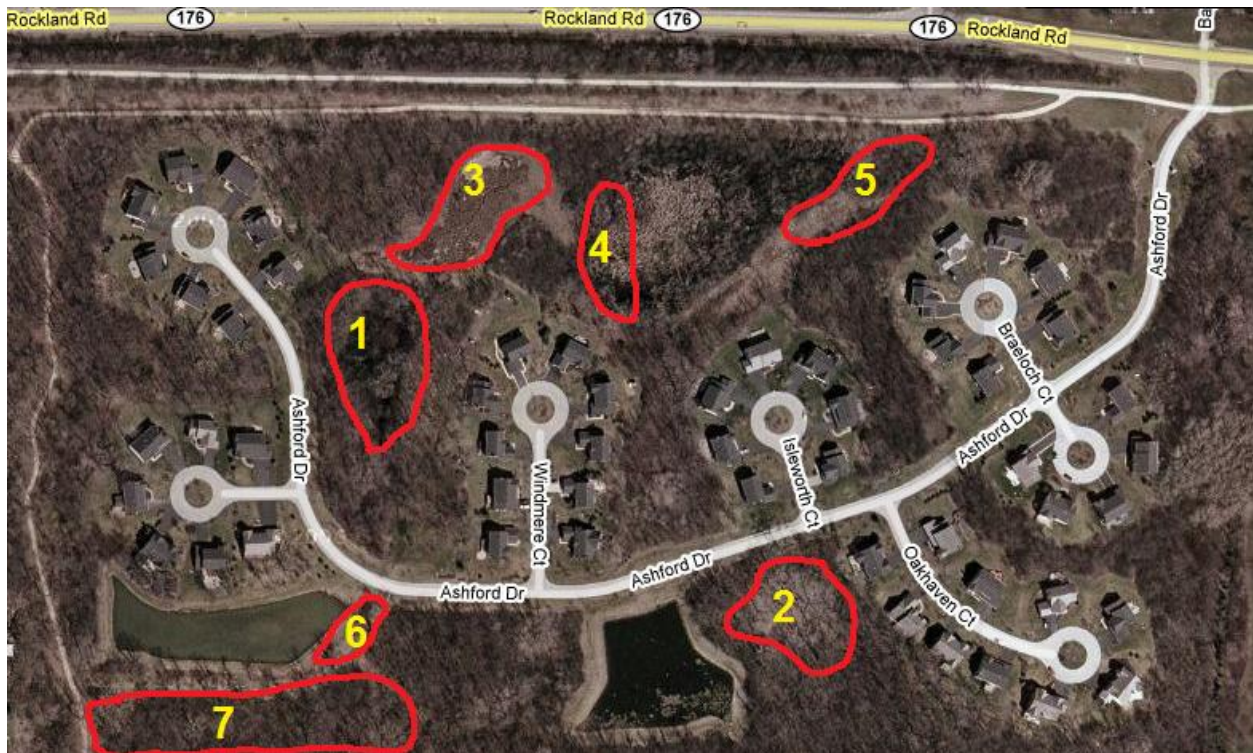
The diagram will be used to reference areas of remediation in the following recap.

- B. Additional dead trees that could be considered hazardous were identified in area 6 identified on the diagram on the path behind the pond on the southwest part of the property. These trees will be considered for remediation at the next board meeting.
- C. There were trees that were trees identified preservation, but they will be addressed in bullet D. There was no time to concentrate on trees for aesthetics as there are too many immediate issues around preservation that must be addressed first.
- D. There are 4 critical areas that need to be remediated for drainage that threaten forestation.
